Technical Assistance Project
Vail Wastewater Treatment Facility
Vail, Colorado, March - April 1973

Environmental Protection Agency

1973

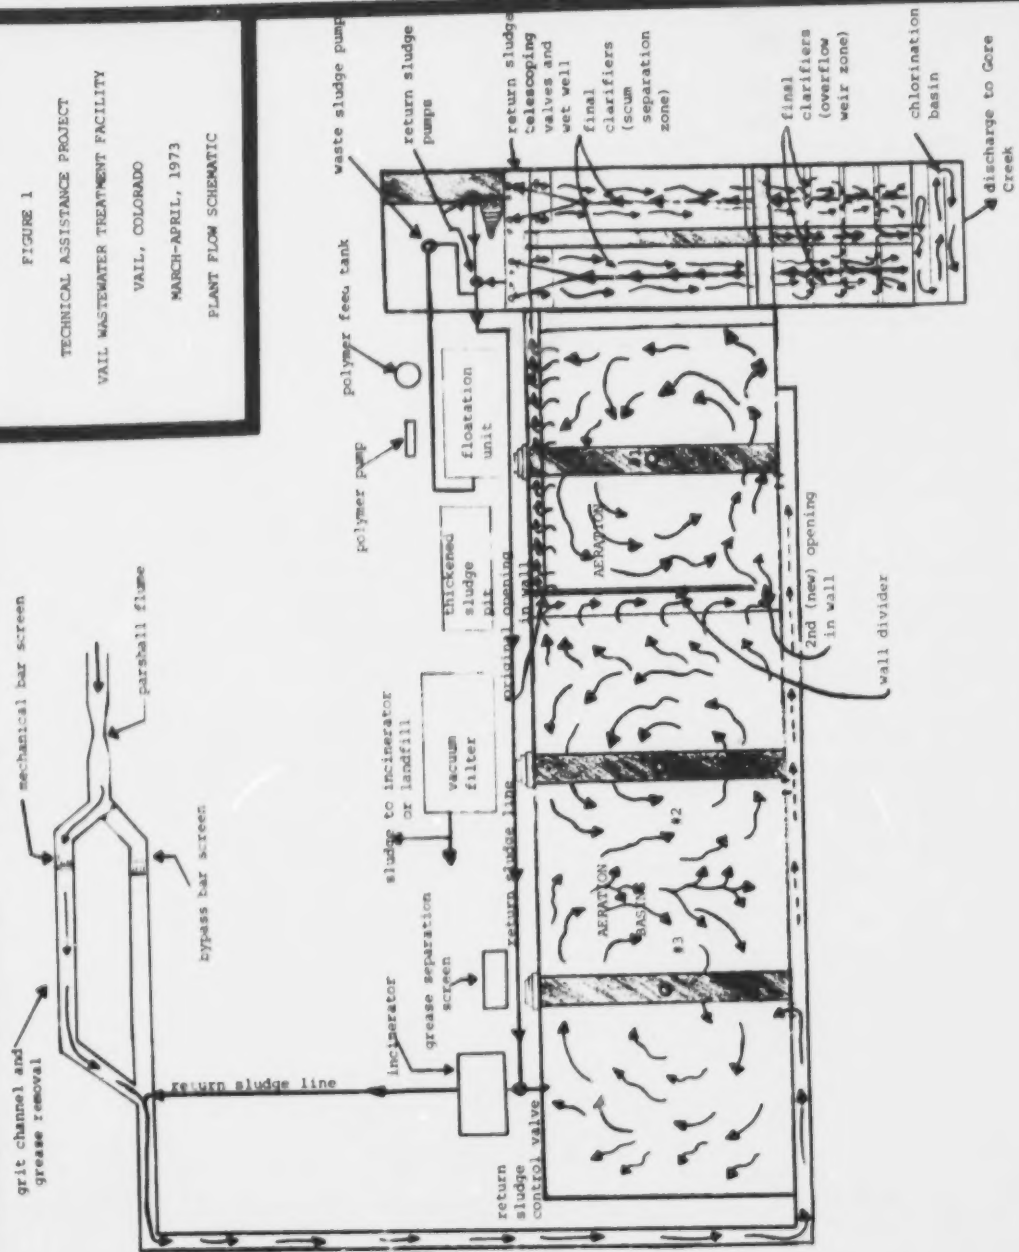
FIGURE 1
 TECHNICAL ASSISTANCE PROJECT
 VAIL WASTEWATER TREATMENT FACILITY
 VAIL, COLORADO
 MARCH-APRIL, 1973
 PLANT FLOW SCHEMATIC

Flow enters the plant and is directed through a parshall flume, bar screen, and grit channel before entering the aeration basins. Flow may enter the aeration basins at the head end, near aerator #3, half way down, near aerator #2, or at the far end of the basin, near aerator #1. A concrete wall is located near the end of the aeration basins and physically separates aeration basin #1 from basins #2 and #3. During the initial EPA evaluation made at the Vail plant it was recommended that an opening be provided in the wall between basin #1 and basins #2 and #3 to allow for series operation.

To eliminate the inadequacies posed by the concrete wall it was recommended that a second opening be placed in the concrete wall to enable flow from basins #2 and #3 to pass directly to basin #1. Plant personnel acted on this recommendation and a second opening in the wall was made prior to the beginning of the formal technical assistance project.

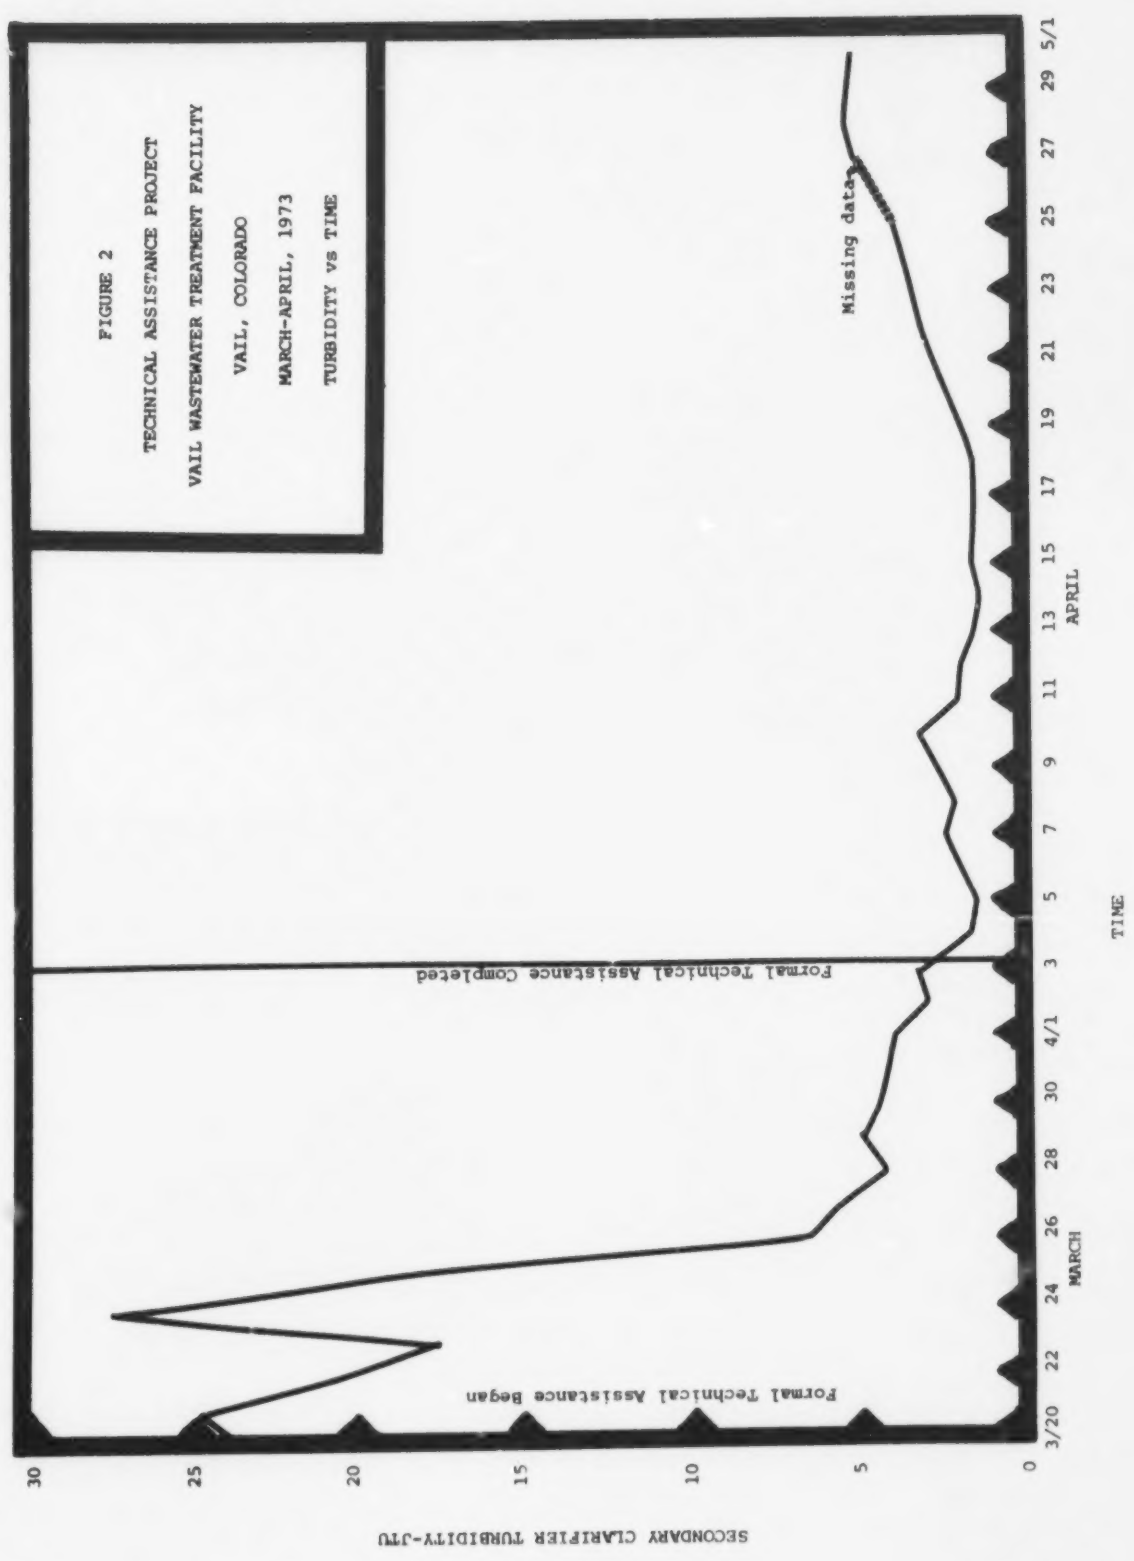
FIGURE 2
 TECHNICAL ASSISTANCE PROJECT
 VAIL WASTEWATER TREATMENT FACILITY
 VAIL, COLORADO
 MARCH-APRIL, 1973
 TURBIDITY vs TIME

Figure 2 shows the daily average turbidity values of the clarified effluent during and after the assistance project. It should be noted that in all cases attempts were made to exclude suspended solids in the turbidity sample. The purpose of the turbidity test was to indicate the ability of the mixed liquor suspended solids in the aeration basin to convert colloidal and dissolved BOD₅ in the waste stream to sludge solids. A high turbidity normally indicates a larger quantity of colloidal and dissolved BOD₅ present in the clarifier effluent and low turbidity normally indicates smaller quantities of colloidal and dissolved BOD₅ in the clarifier effluent. It is noted that a low turbidity value reported as outlined above does not necessarily mean low effluent total

Figure 2 shows a dramatic decrease in the turbidity within one week after the beginning of the assistance project and a continued decrease in turbidity until formal assistance was completed. The dramatic decrease in turbidity was the result of the changes in plant operation as discussed earlier in the report, (e.g. changed plant mode of operation, changed return sludge flow operation, changed aerator operator operation, etc.). The continued slower decrease in turbidity after the initial drop indicates the length of time required for the activated sludge biological system to change and develop. After the formal technical assistance project was completed the turbidity increased, then decreased, and then increased again. These changes in turbidity indicate the continued problems encountered with the final clarifiers and the resultant solids loss due to uncontrollable "sludge bulking". Sludge bulking occurred primarily because of inadequate flow distribution to the two final clarifiers. The uncontrolled solids loss caused lower MLSS concentrations resulting in additional colloidal and dissolved BOD₅ in the plant effluent.

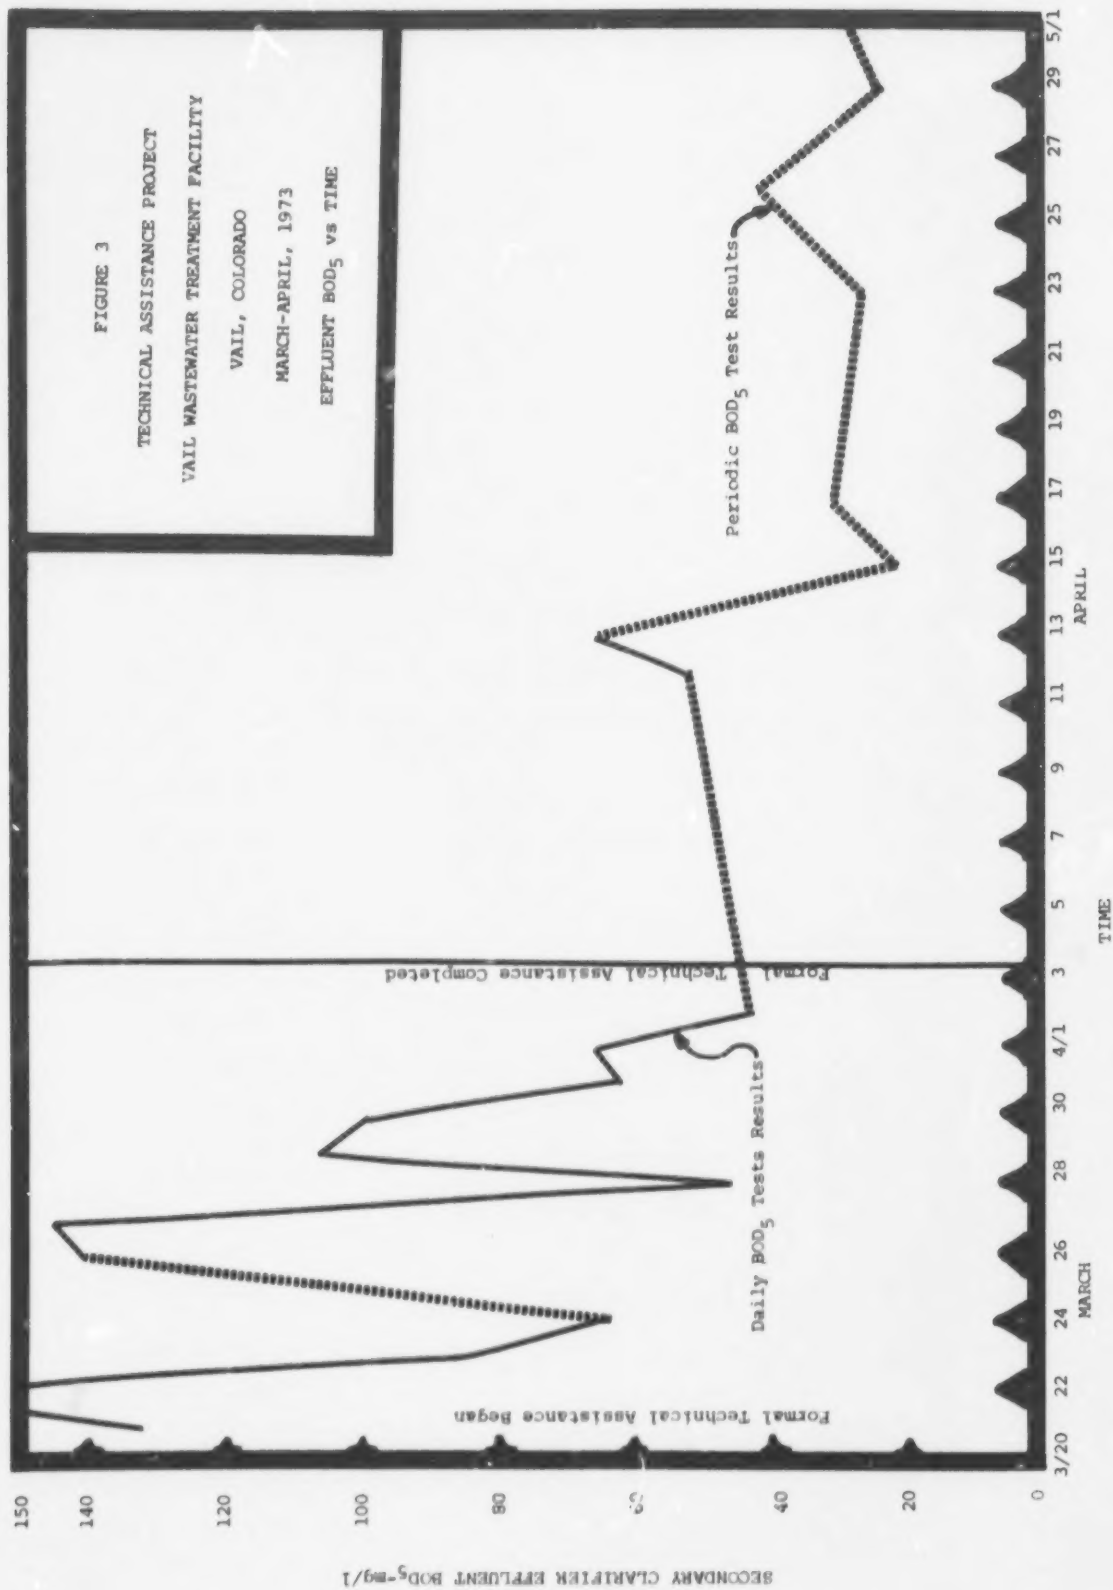
Figure 3 shows the daily composited secondary clarifier effluent BOD₅ test results. At the beginning of the assistance project most of the BOD₅ in the effluent was due to the colloidal and dissolved organic matter, (refer to Figure 2 for an indication of amount of colloidal and dissolved organic matter in the effluent as measured by turbidity). During assistance less of the BOD₅ was due to colloidal and dissolved organic matter and more of the BOD₅ was due to suspended solids "lost" in the effluent. As can be seen from Figure 3, a drastic reduction in the BOD₅ occurred during the assistance project (i.e. approximately 110 mg/l to 45 mg/l) and an even further reduction occurred after

formal assistance was completed (i.e. approximately 45 mg/l to 30 mg/l). However, the present Colorado Water Quality BOD₅ Standard (30 mg/l) was not consistently being met. The primary reason this standard was not met was the continued problems associated with the final clarifier. If the problems with the final clarifiers are eliminated, it is felt that the Vail treatment facility will be capable of consistently discharging BOD₅ and suspended solids concentrations less than 30 mg/l.

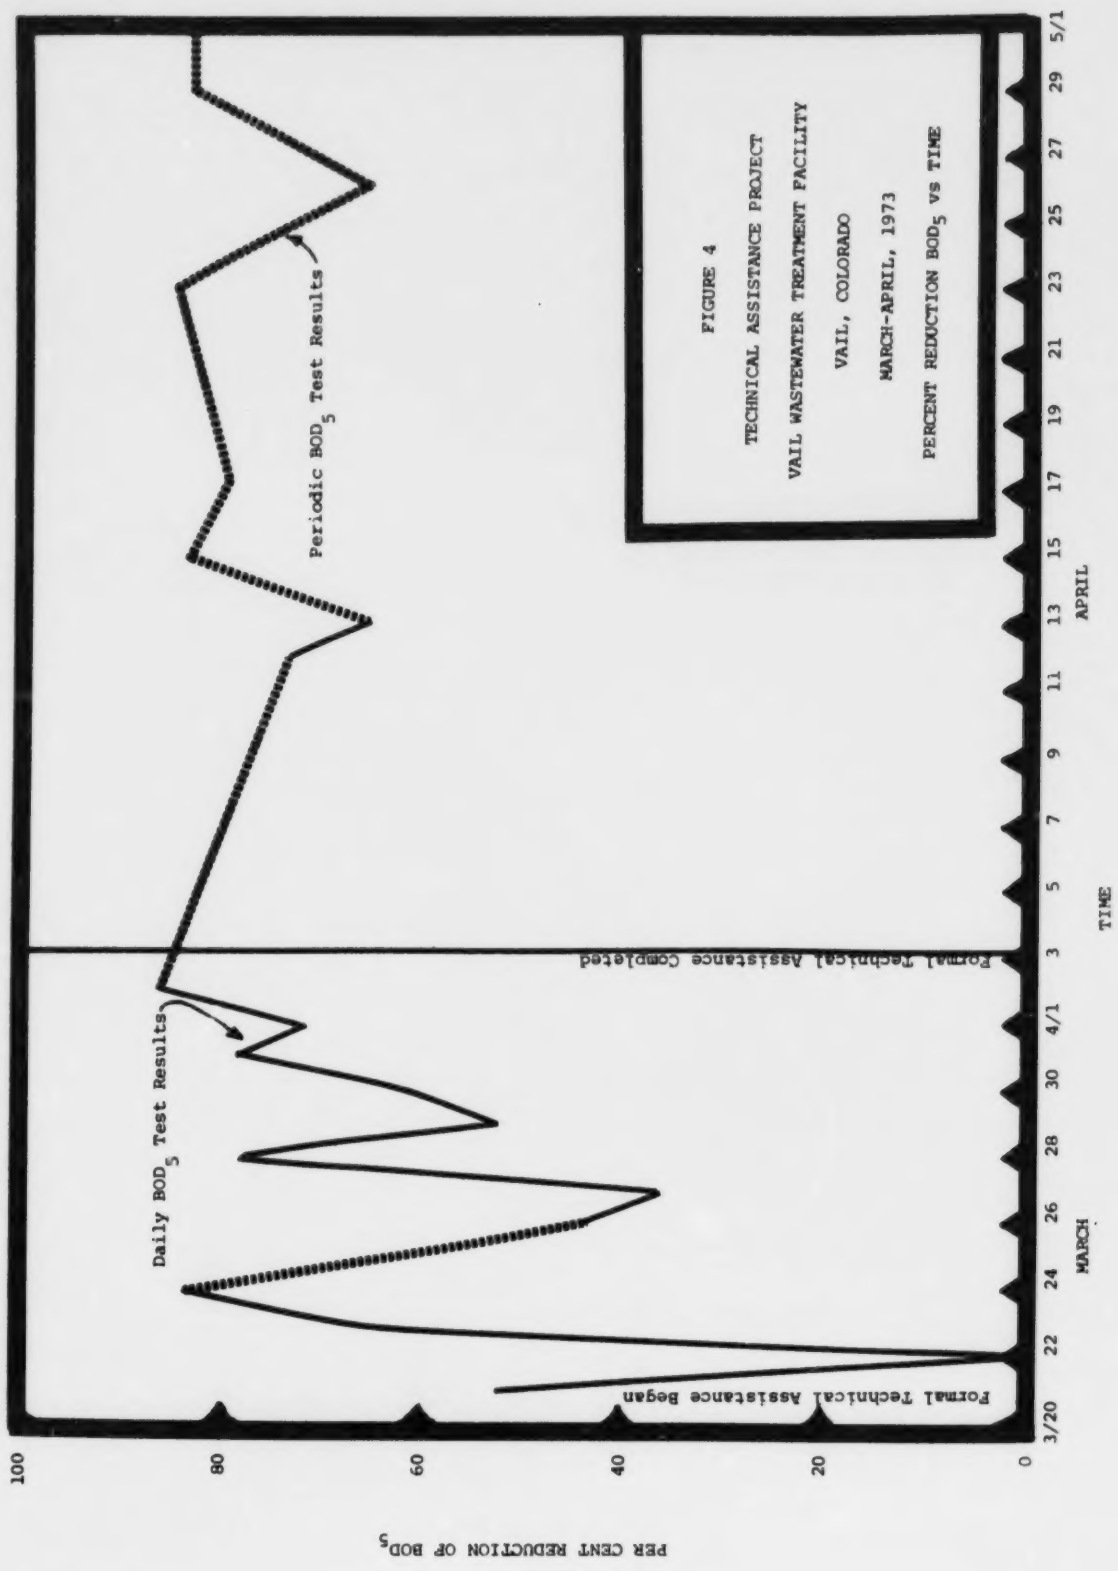
The reduction in clarifier effluent BOD₅ due to technical assistance represents nearly a 73% reduction in BOD₅ or a reduction of about 136.2 Kg (300 lbs.) of BOD₅ per day in the effluent (assume average plant flow of 1,703 cu m/day (450,000 gal/day) during assistance). Figure 4 shows that the present reduction in BOD₅ through the Vail facility increased from about 45% to about 75% due to assistance.

Greater reductions can be expected with appropriate modifications to the secondary clarifiers.
